**PERFORMANCE OF RIGID PAVEMENTS CONTAINING
RECYCLED CONCRETE AGGREGATES**

THESIS

Civil Engineering

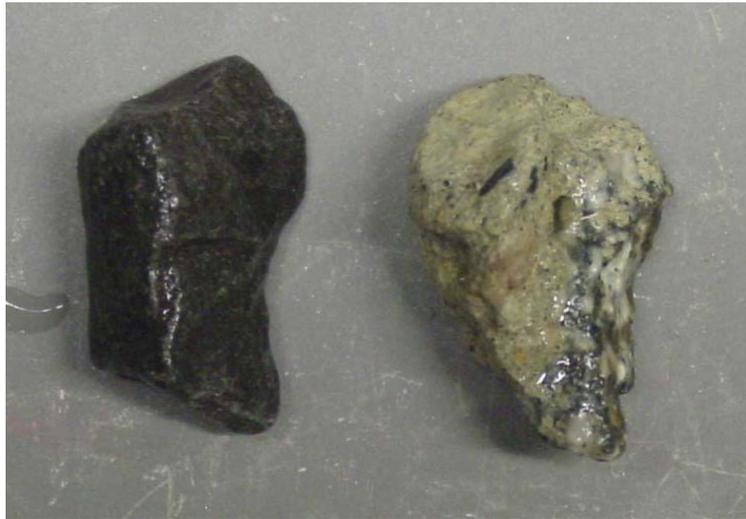
Figure 1: Original Aggregate (left) and Recycled Concrete Aggregate (right)

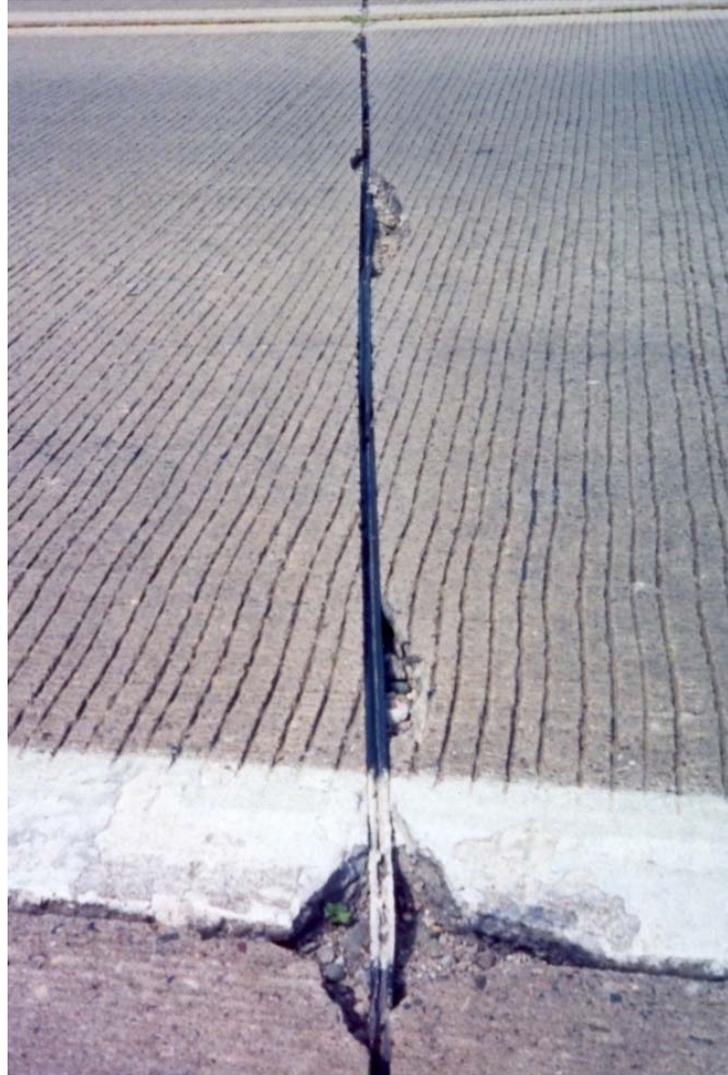
Figure 3: Severe Transverse Joint Spalling

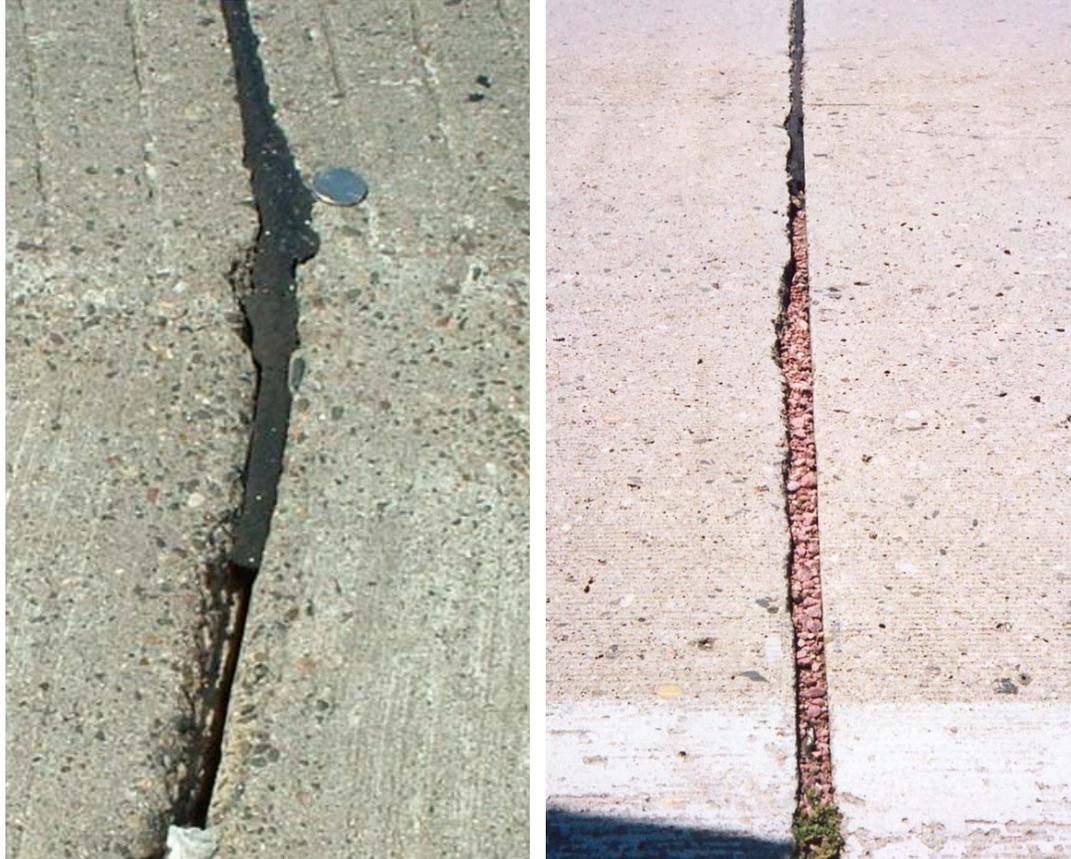
Similar to transverse joint spalling, the amount and degree of damage was recorded as low, medium or high severity. If the seal had totally disintegrated or if the joint was never sealed then it was noted on the form. This test was done visually and if severe joint damage was present then it was documented on the form and a photograph was taken. A couple photographic examples of transverse joints with seal damage are shown in Figure 4.

Figure 4: Transverse Joints with Seal Damage

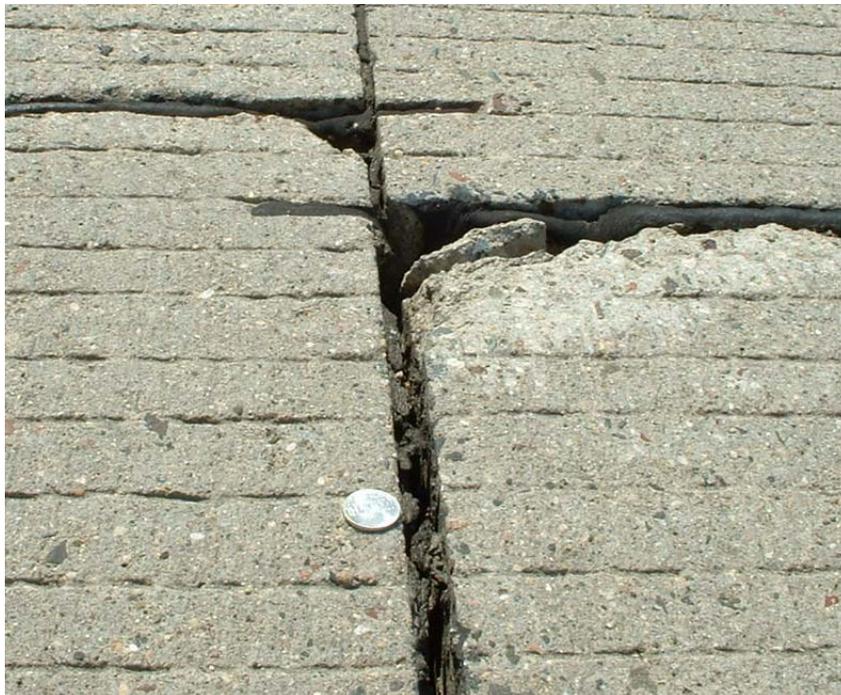
longitudinal joint studied was the one between the slow lane and the next lane over. For two lane highways the longitudinal joint studied was in between the test strip and the opposing traffic lane. The amount and degree of damage was recorded as low, medium or high severity. If the seal had totally disintegrated or was not present then it was noted on the form. This was done visually and if severe joint damage was present then it was documented on the form and a photograph was taken. A photographic example of a longitudinal joint with seal damage is shown in Figure 5.

Figure 5: Longitudinal Joint with Seal Damage

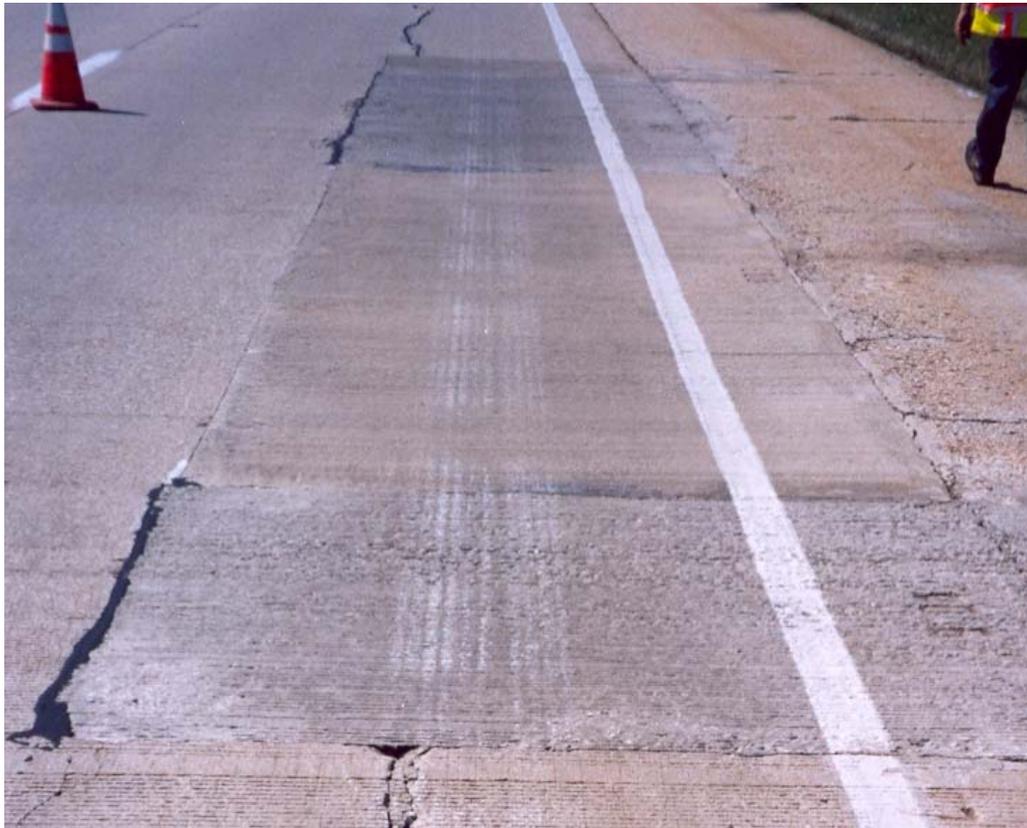
Slab/Patch deterioration occurs when a patch that was placed on part or all of a concrete slab starts to show signs of wear.¹⁴ For this study there were a couple ways of surveying this. First, if a patch was put down and noted in the 1994 study then it was analyzed for distress in 2006. Second, if a patch was new to the 2006 study then it was sketched out on the road plan and then evaluated for distress. The degree of distress for both cases would be recorded as low, medium or high. An example of a pavement patch with high distress is shown in Figure 7.

Figure 7: Slab Patch Intersection with Distress

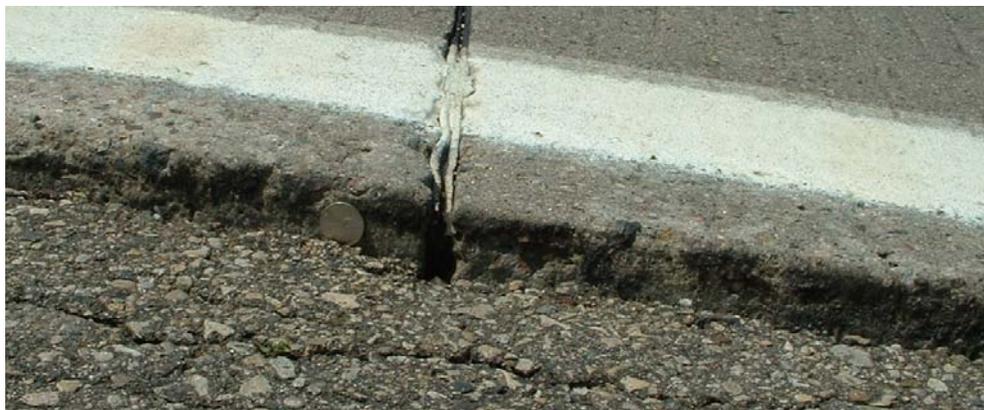
A lane to shoulder drop off measurement was usually taken once every 3 or 4 slabs or whenever a severe drop off was noticed. Figure 9 shows a severe drop off.

Figure 9: Severe Lane to Shoulder Drop off

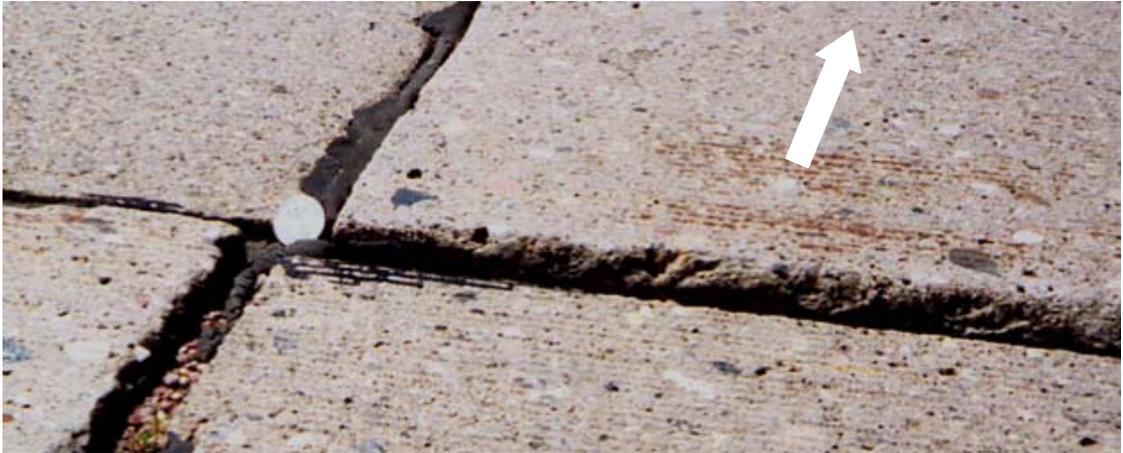
an example of extremely large faulting between panels. The white arrow represents the direction of traffic. Some lateral movement over the longitudinal joint can also be seen.

Figure 11: Large Faulting Between Panels

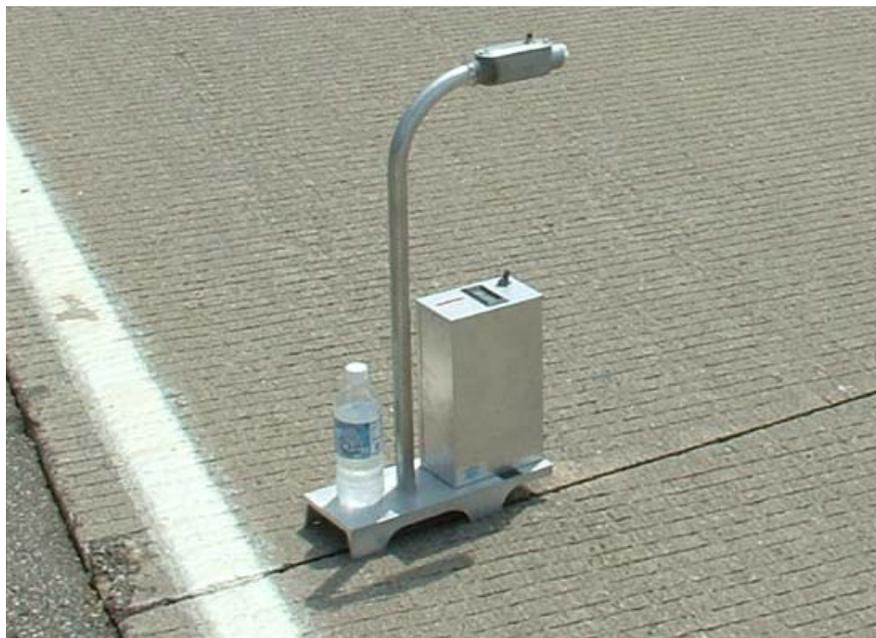
The faulting between panels value was measured in the outer wheel path of the lane (typically 30 – 45 cm from the outer edge of the pavement). Each transverse joint between panels was measured. A value was given to the nearest tenth of a millimeter. To measure this value, a Georgia Faultmeter was used, as shown in Figure 12.

Figure 12: Georgia Faultmeter

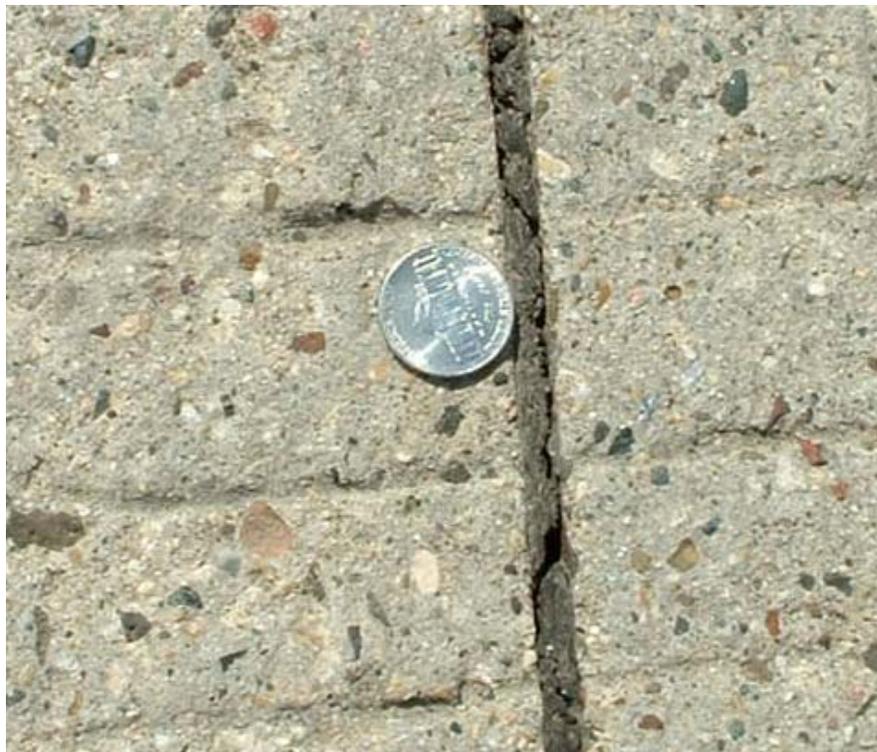
The joint width was measured as the horizontal distance between the transverse edges of two abutting slabs.¹⁴ Similar to the faulting between panels measurement, this value was measured in the outer wheel path of the lane (typically 30 – 45 cm from the outer edge of pavement). A crack comparator card was used to measure this value. Each transverse joint between panels was measured. A value was given to the nearest tenth of a centimeter. Figure 13 shows an example of a typical transverse joint width.

Figure 13: Typical Transverse Joint Width

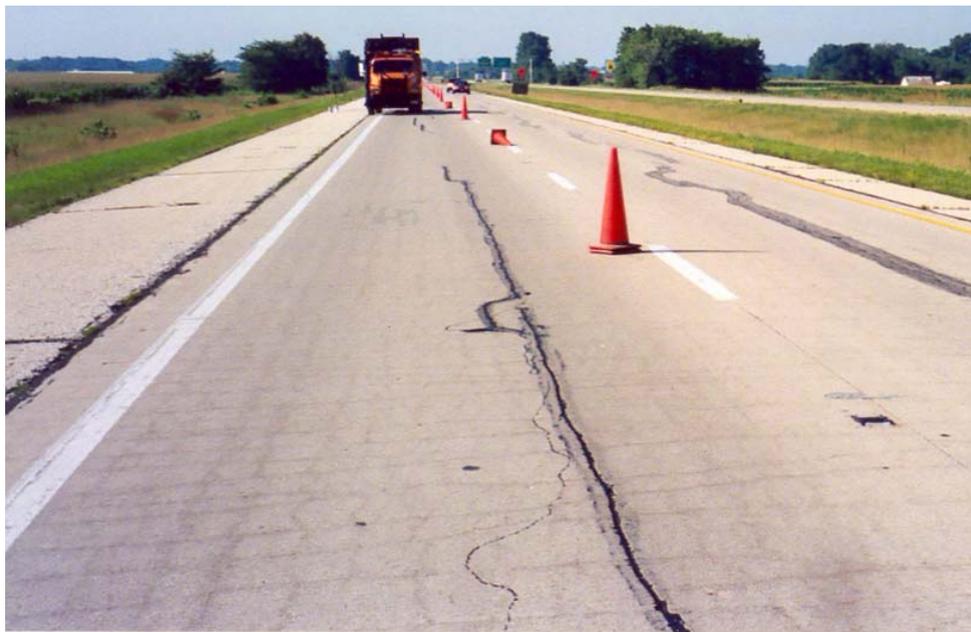
Longitudinal cracks are cracks that generally run parallel to the flow of traffic or a roads centerline.¹⁴ The severity of a longitudinal crack was recorded as low, medium or high. The crack's length and position was estimated and sketched on a road plan supplied in the survey sheet. Figure 14 shows an example of a medium severity longitudinal crack.

Figure 14: Medium Severity Longitudinal Crack

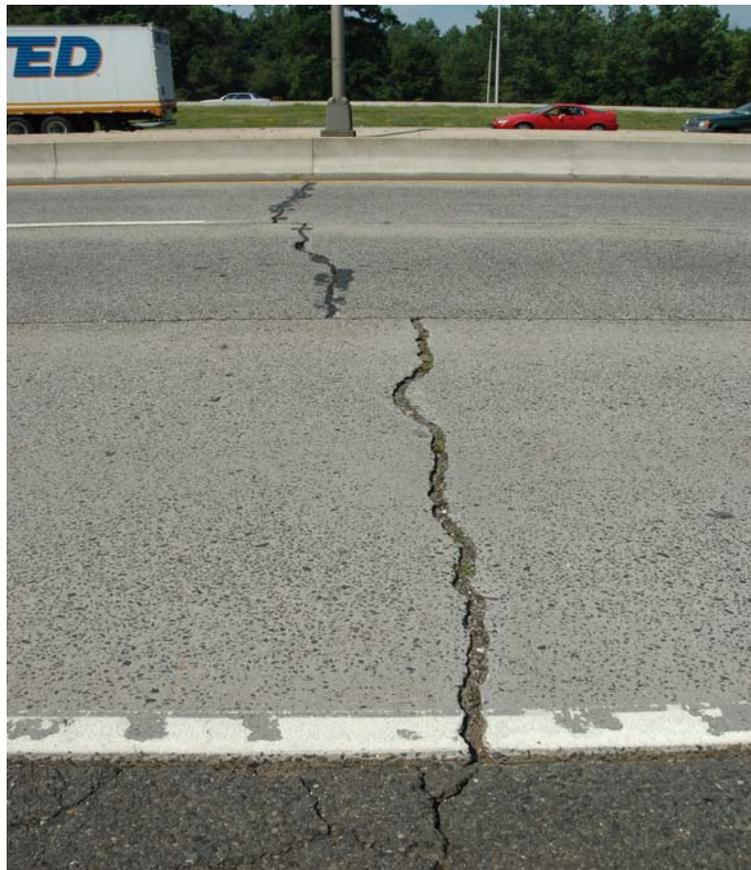
Transverse cracks are cracks that generally run perpendicular to the flow of traffic or a roads centerline.¹⁴ The severity of a transverse crack was recorded as low, medium or high. The cracks length and position was estimated and sketched on a road plan supplied in the survey sheet. Figure 15 shows an example of a high severity transverse crack.

Figure 15: High Severity Transverse Cracks

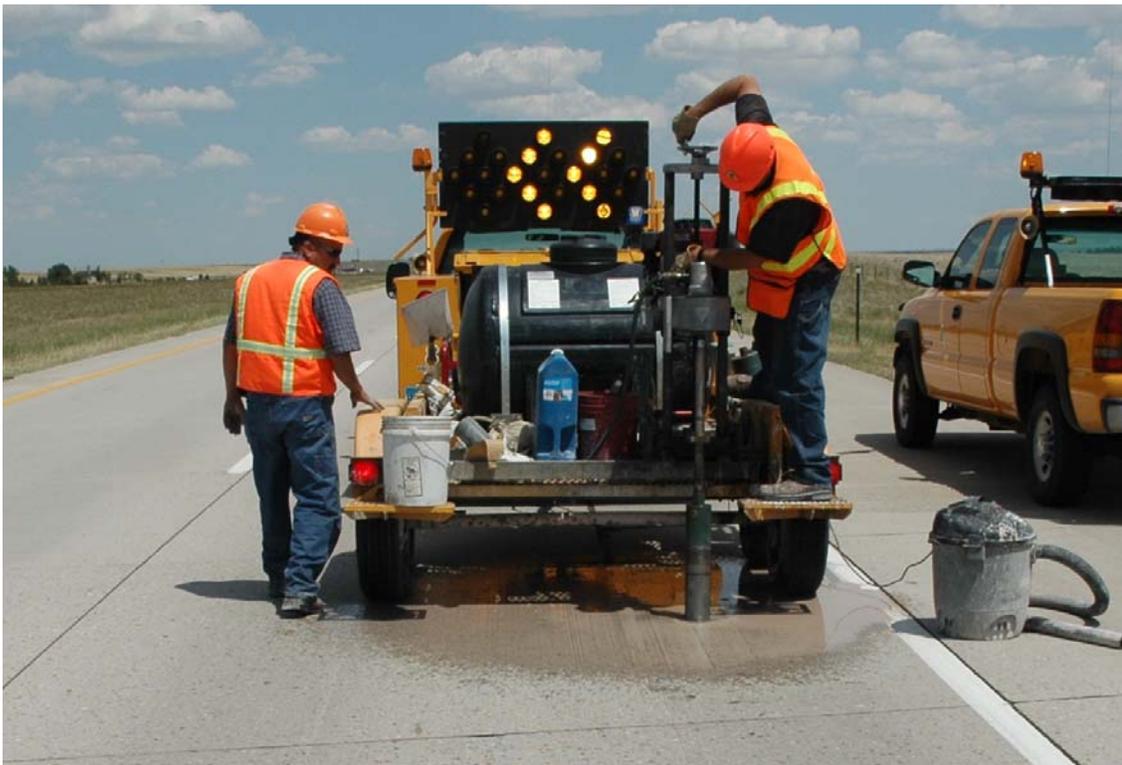
Figure 17: WYDOT Crew Members Extracting a Pavement Core

bono. Similar to the 1994 study, these cores were taken at various locations along the test strip (i.e. mid-panel, joint). For sections tested in 1994, the locations of the 2006 cores were selected to be as close to those of the 1994 study as possible. The coring locations were marked with spray paint and were noted on the road plan. Crew members extracted cores while the pavement survey data were recorded. Figure 17 shows crew members from the Wyoming Department of Transportation extracting a core.

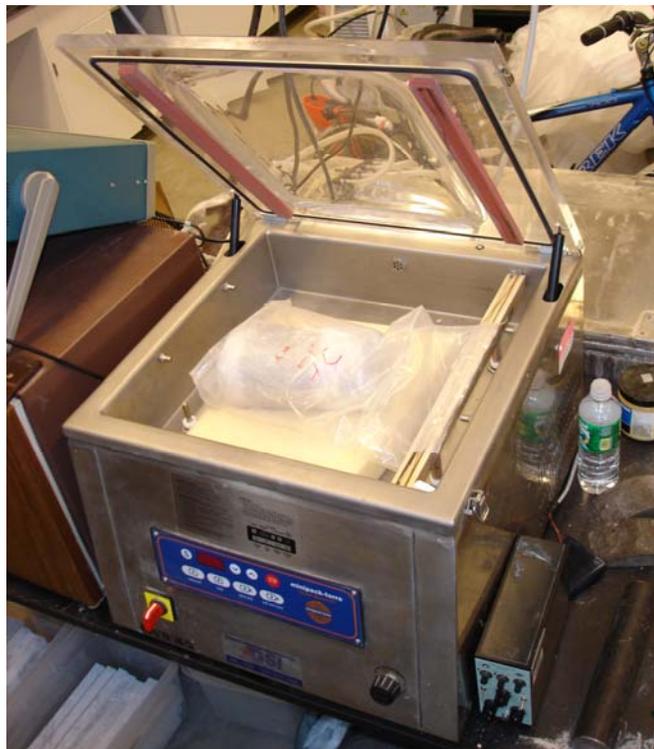
Once the cores from each site arrived at UNH they were vacuum sealed to keep them at a constant environment. Each core was wrapped with bubble wrap to keep sharp edges from breaking the vacuum seal. Cores were then inserted into a vacuum bag and vacuum sealed to 99.9% in a General Services Incorporated MVS 45 industrial vacuum sealer. A core set up to undergo vacuum sealing is shown in Figure 18.

Figure 18: Core in Vacuum Sealing Machine

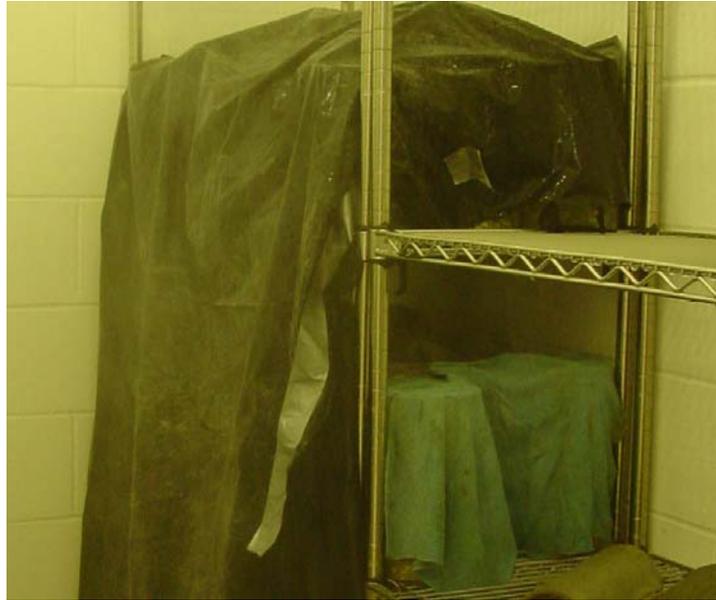
Before splitting tension testing commenced, all of the cores were taken out of their vacuum sealed bags. The ends of each core were cut with a concrete saw so that they were flat and perpendicular to the sides. After cutting the cores they were put into a curing room at 20°C and 100% relative humidity for at least 2 days to normalize the amount of moisture on their outer surface, as shown in Figure 20.

Figure 20: Cores in Curing Room

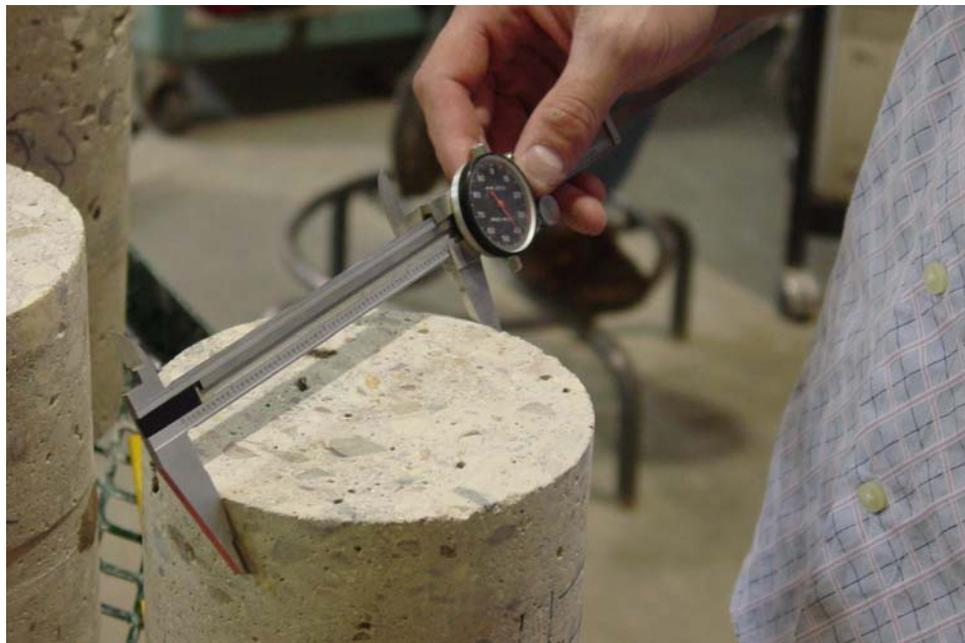
Once the cores were done sitting in the fog room they were taken out and their diameter and length were measured using a caliper, as shown in Figure 21.

Figure 21: Measuring the Diameter of a Cylinder with a Caliper

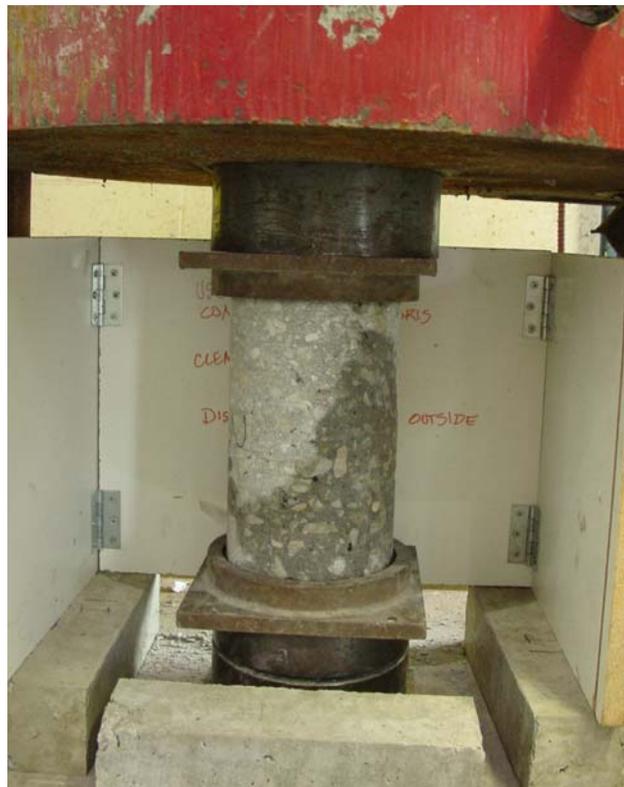
A cylinder is set upright on top of a neoprene padded metal base. This padded metal base was leveled on top of a ball and socket apparatus. A neoprene padded cap was then placed on top of the cylinder. Figure 22 shows a cylinder set up and ready to undergo compression testing on a hydraulic 300 kip capacity Young[®] testing machine.

Figure 22: Core set up for Compression Testing

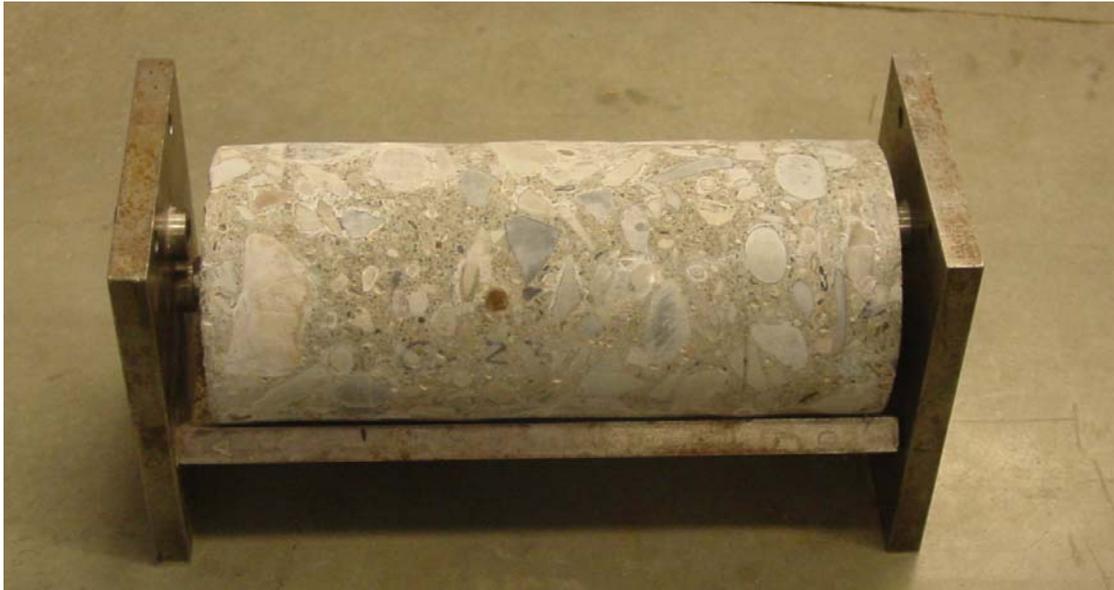
of bushing is exactly 29.5 cm. Figure 24 shows a core being studded inside of the jig.

Figure 24: Core Studding Jig

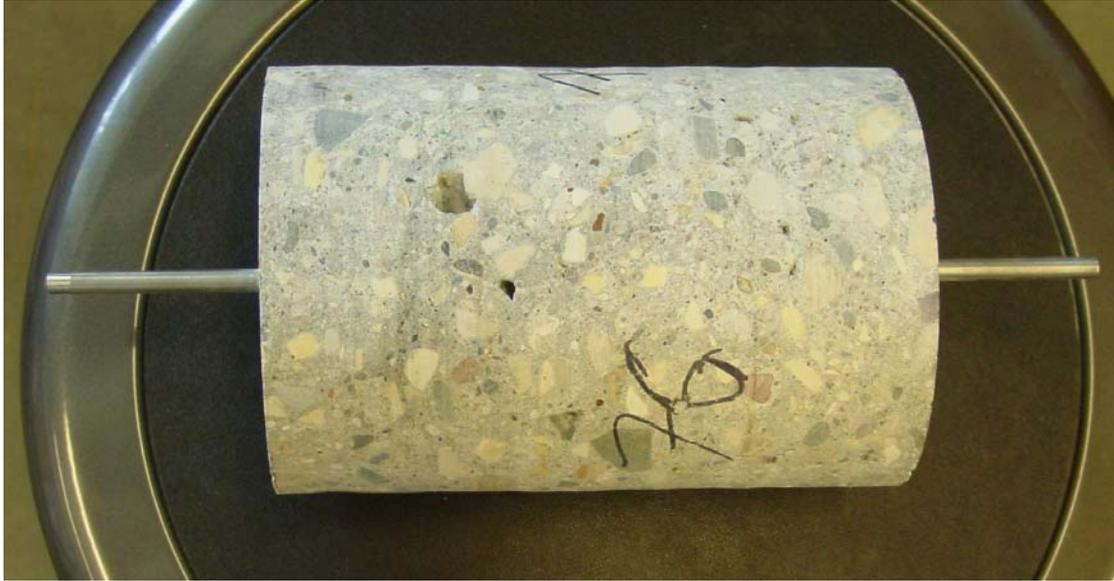
Since expansion occurs over at a slow rate with the ASTM C 1293 test a 1 milliamp electrical current was introduced to the cylinders once testing started. Studies have shown that when ASR susceptible concrete is introduced to an electrical current expansion rates increase.⁵ The expansion rate increase is due to the migration of hydroxyl ions. With the addition of a small electrical current, the hydroxyl ions are better able to infiltrate into reactive aggregate and accelerate expansion.⁵

Figure 25: Studded Core for Modified ASTM C 1293 Testing

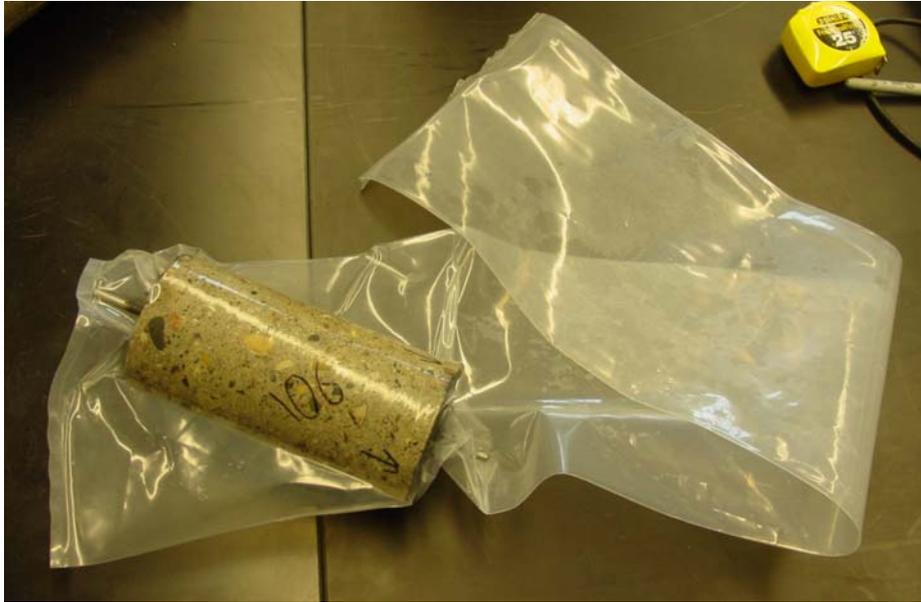
Once time vs. expansion and weight gain became asymptotic it was assumed that saturation was attained. A core under vacuum is shown in Figure 28. After the cores were determined to be at a constant moisture they were stripped from the vacuum sealed bags and their lengths and weights were recorded.

Figure 28: Vacuum Saturated Core

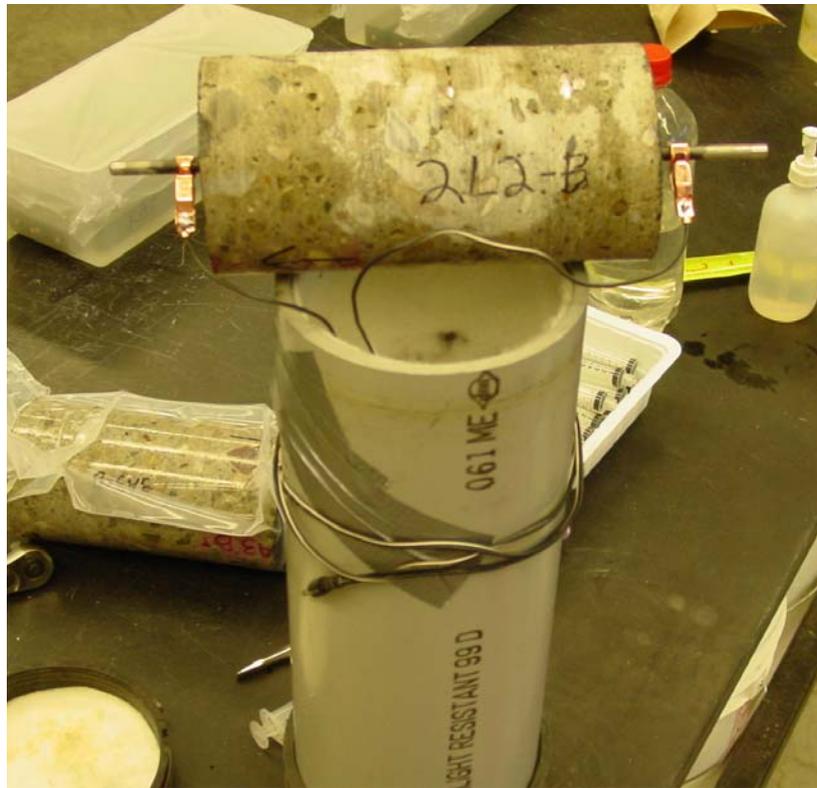
The cores were then prepped for testing by attaching an alligator clip to each stud, as shown in Figure 29.

Figure 29: Modified ASTM C 1293 (Electric Cylinder) Test Setup

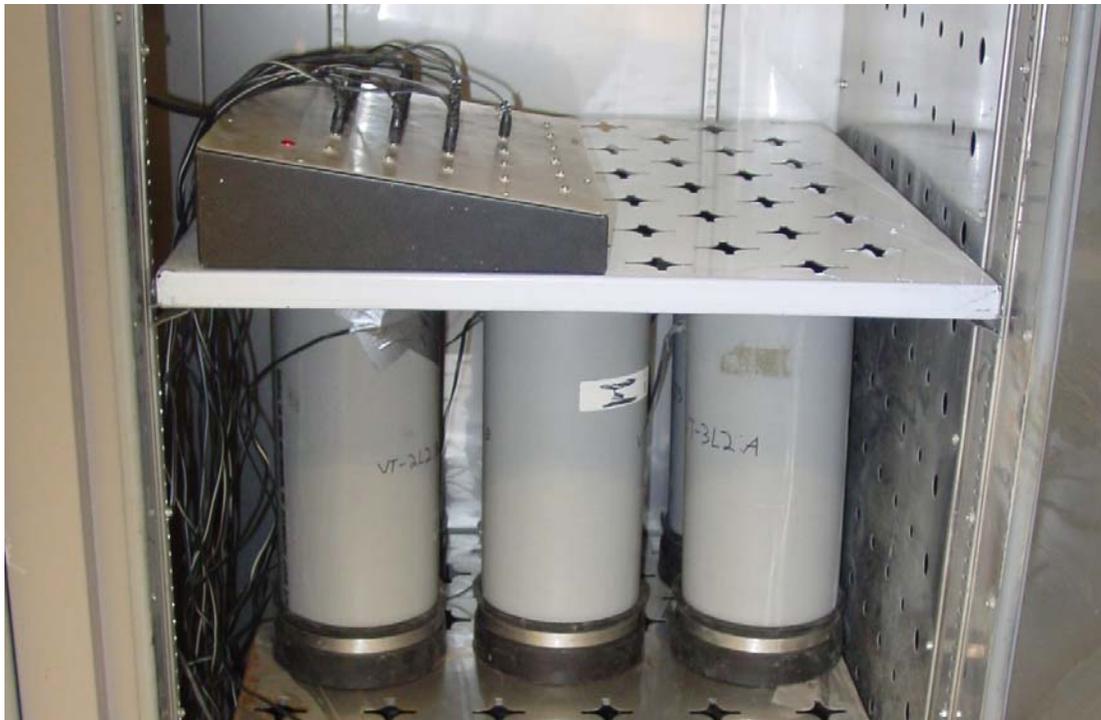
An inch of water was then placed into the storage container, the core was set up vertical and the container was sealed and placed into the 38 °C oven. Each cylinder was then supplied a constant 1 milliamp of current. When a measurement was taken the current to the cylinders was stopped and the containers were taken out of the oven and left out overnight to cool to room temperature, as per ASTM C 1293. Length and weight measurements were taken at 3, 7, 14, 38, 60, 90 and 108 days. Core storage in the oven is shown in Figure 30.

Figure 30: Modified ASTM C 1293 Core Storage Containers in Oven

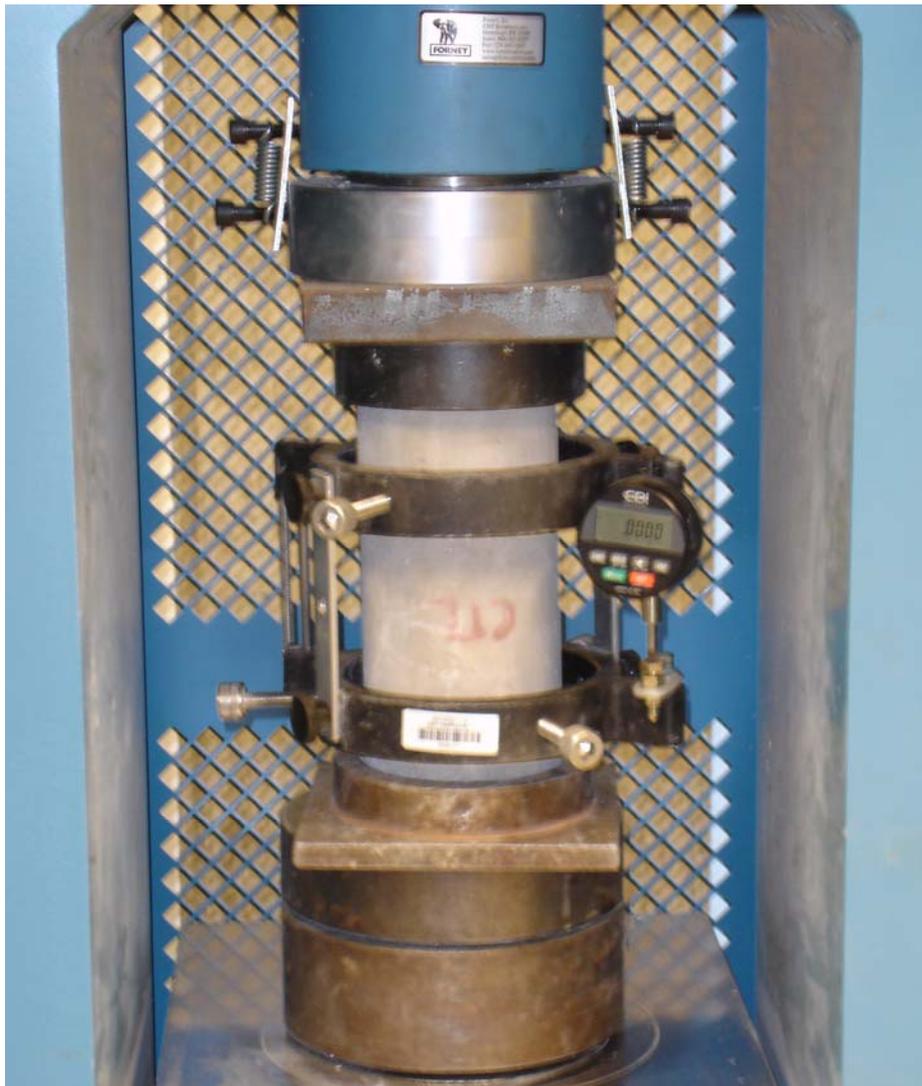
cylinder. The load was applied until it reached 40% of the ultimate load, where the axial strain was measured.²¹ In addition to 40%, at approximately 10%, 20% and 30% of the ultimate load the axial strain was recorded. Once at 40% of the ultimate load the load was taken off. The deformation returned to zero and the test was performed at least two more times for repeatability. Figure 31 shows a cylinder set up and ready to undergo Young's Modulus testing.

Figure 31: Core set up for Young's Modulus Testing

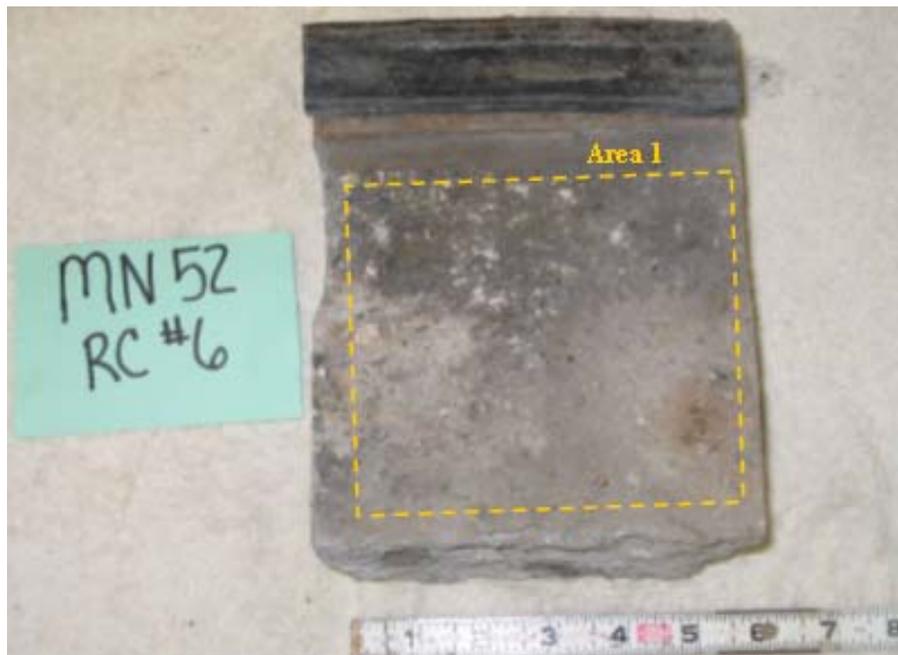
Before the test was started the two sides of the joint core were pulled apart and a sample area was assigned to each half on the joint face, as seen in Figure 33.

Figure 33: Typical Joint Face Area used for VST Testing²²

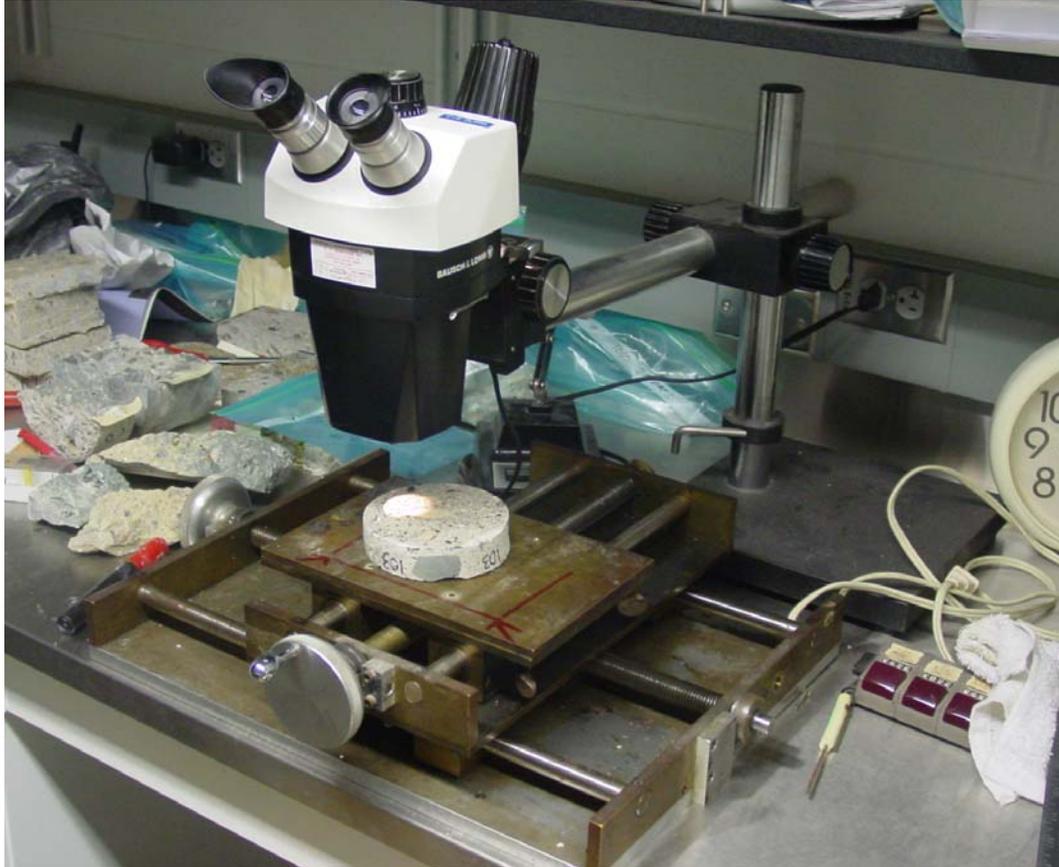
Figure 35: Olympus® SZH10 Stereo Microscope used for Petrographic Study

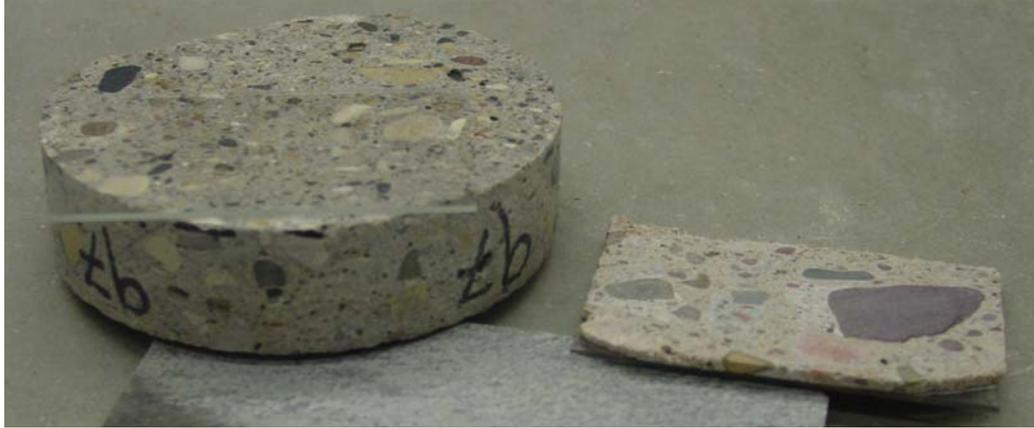
Figure 36: Original Core Cap and Thin Section Epoxy to Glass Slide

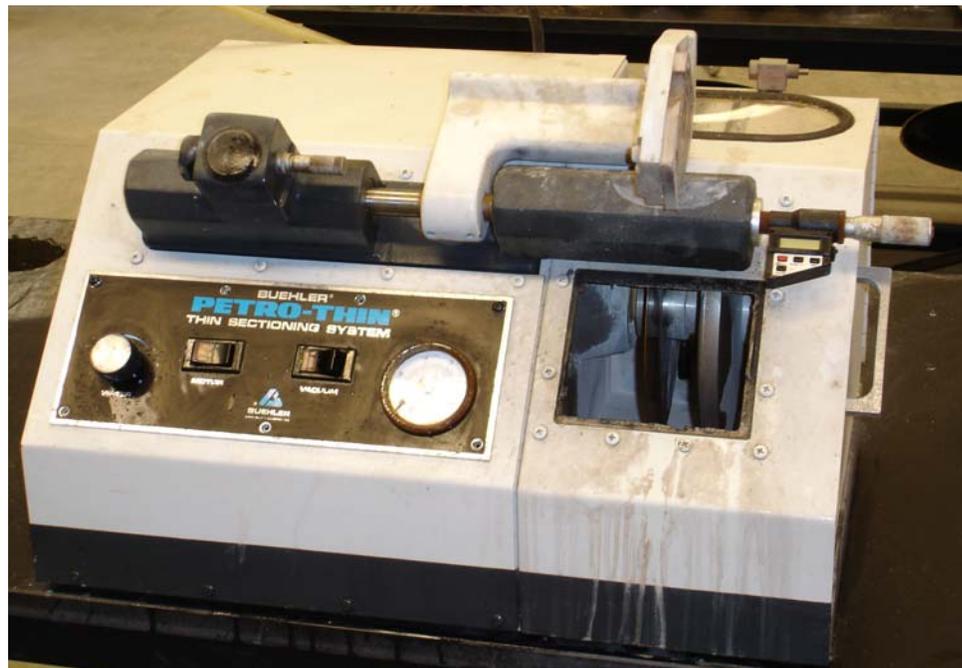
Figure 37: Buehler® Thin Sectioning Machine

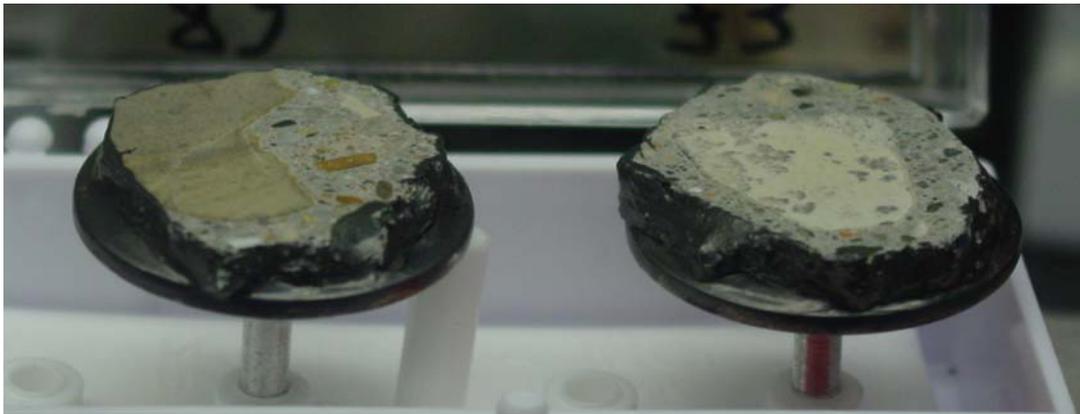
Figure 38: SEM Stubs with Affixed Concrete Specimens

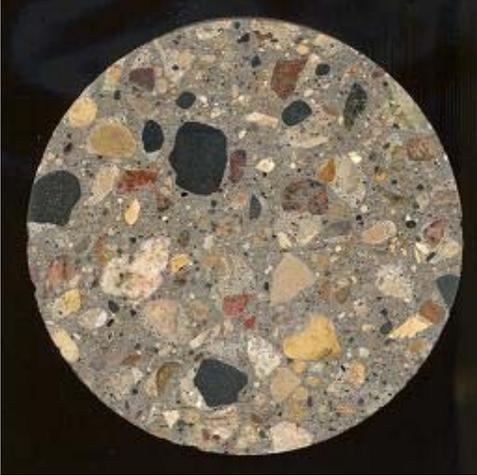
<p style="text-align: center;">MN3-1</p>

<p>A circular polished core cross section showing a matrix of light gray material with numerous small, dark, angular fragments and some larger, yellowish-brown grains.</p>	
<p style="text-align: center;">MN4-1</p>

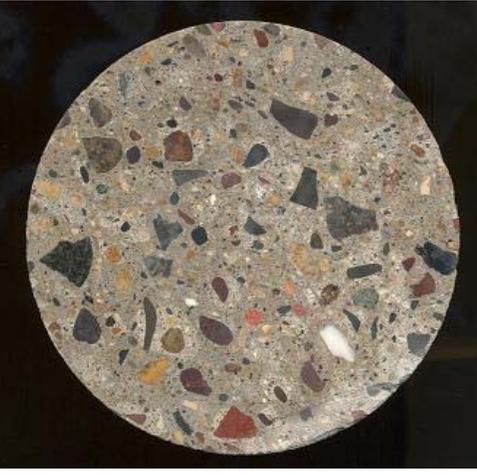
<p>A circular polished core cross section showing a matrix of light gray material with numerous small, dark, angular fragments and some larger, yellowish-brown grains.</p>	<p style="text-align: center;">MN4-2</p>

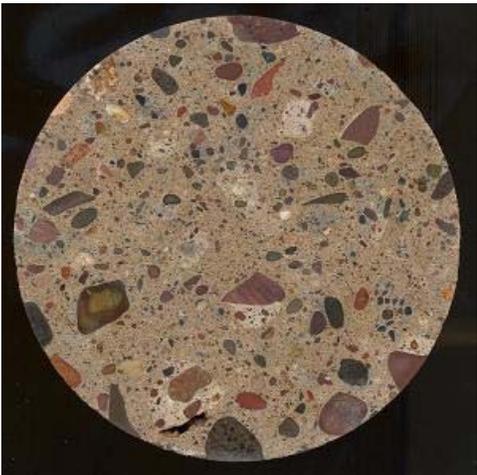
<p>A circular polished core cross section showing a matrix of light gray material with numerous small, dark, angular fragments and some larger, yellowish-brown grains.</p>	<p style="text-align: center;">WI1-2</p>

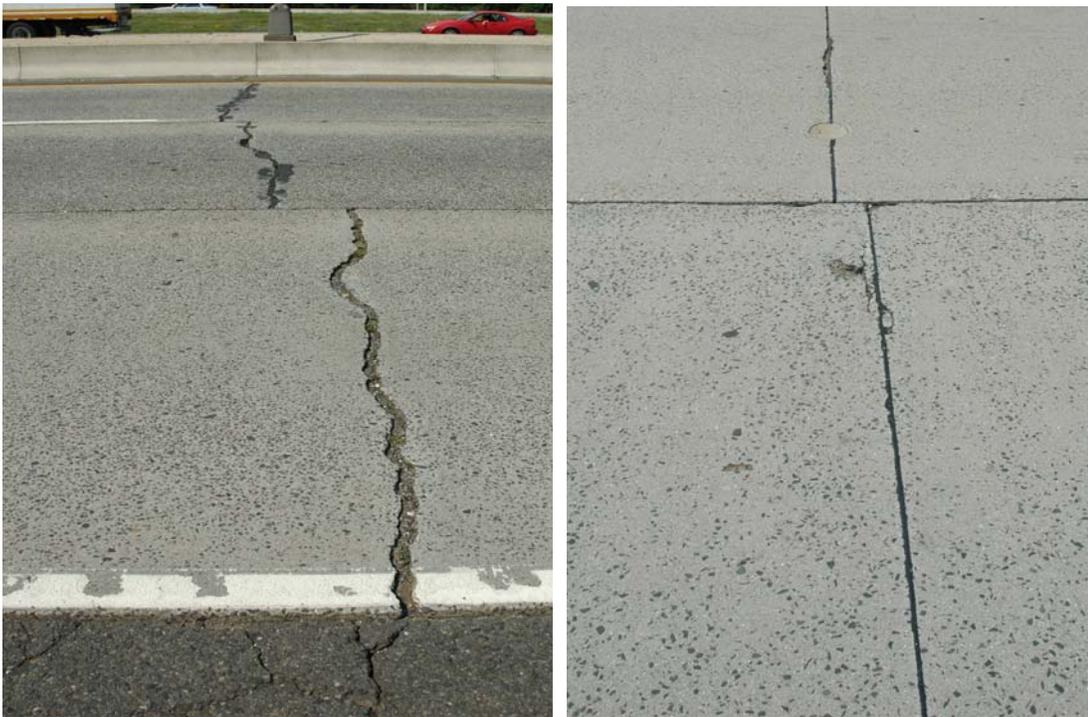
Figure 48: Shift in Outside Lane Panels (CT)

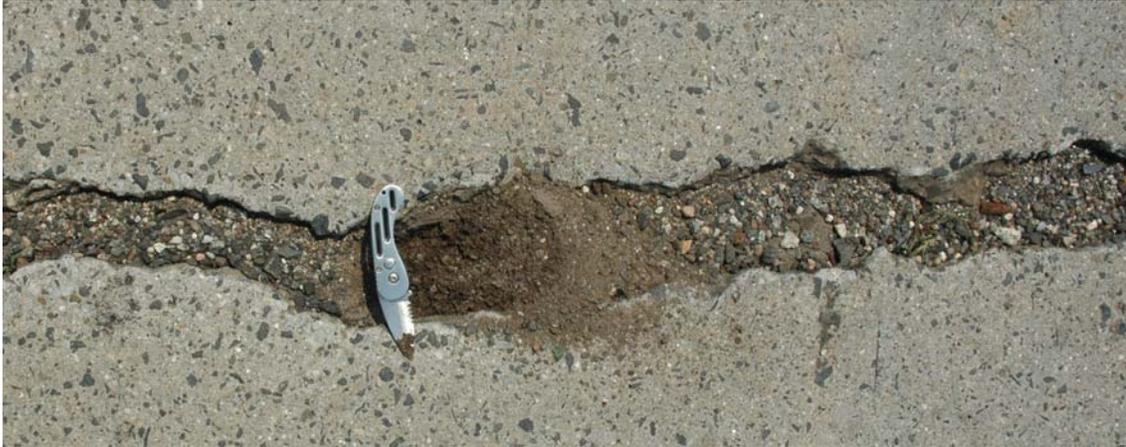
Figure 49: Typical Transverse Crack found on CT1-1 and CT1-2

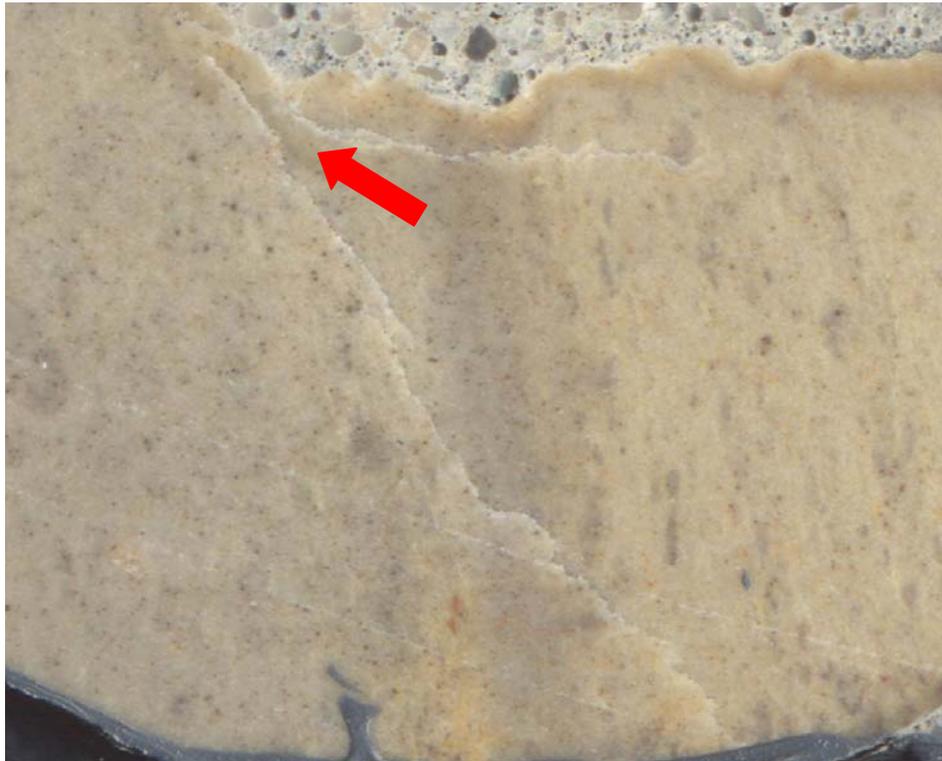
Figure 52: W12-2 Aggregate Crack with ASR Gel Deposit

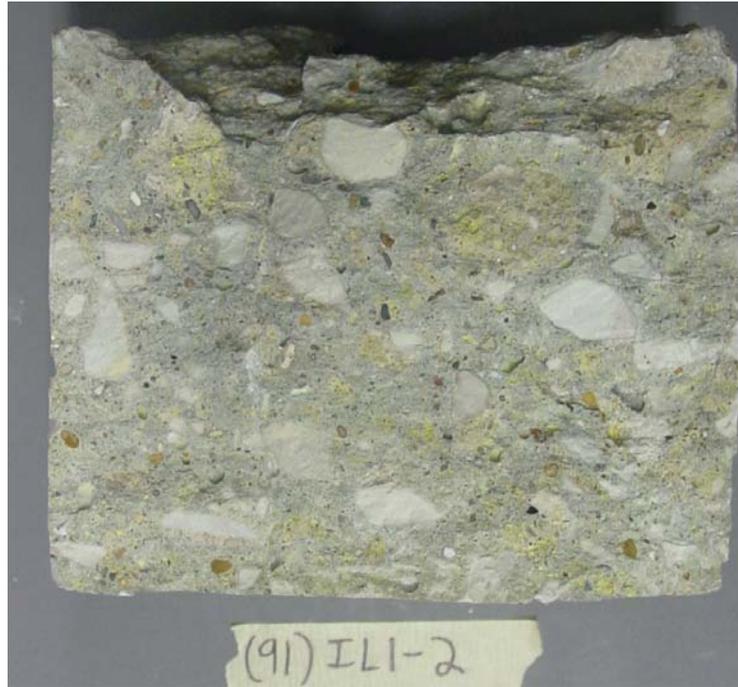
Figure 54: Fractured Core 91 (IL 1-2) coated with Uranyl Acetate Dihydrate under regular light
