**PERFORMANCE OF RIGID PAVEMENTS CONTAINING
RECYCLED CONCRETE AGGREGATES**

THESIS

Civil Engineering

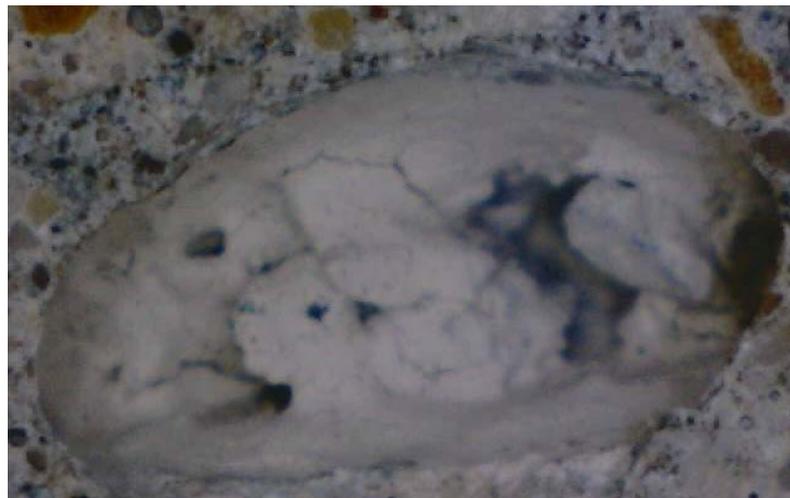
Figure 57: IL1-2 Void filled with ASR Gel
